Death in the line of duty...

A summary of a NIOSH fire fighter fatality investigation

March 11, 2009

Career Fire Captain Electrocuted After Contacting Overhead Powerline From the Platform of an Elevating Platform Fire Apparatus – Pennsylvania

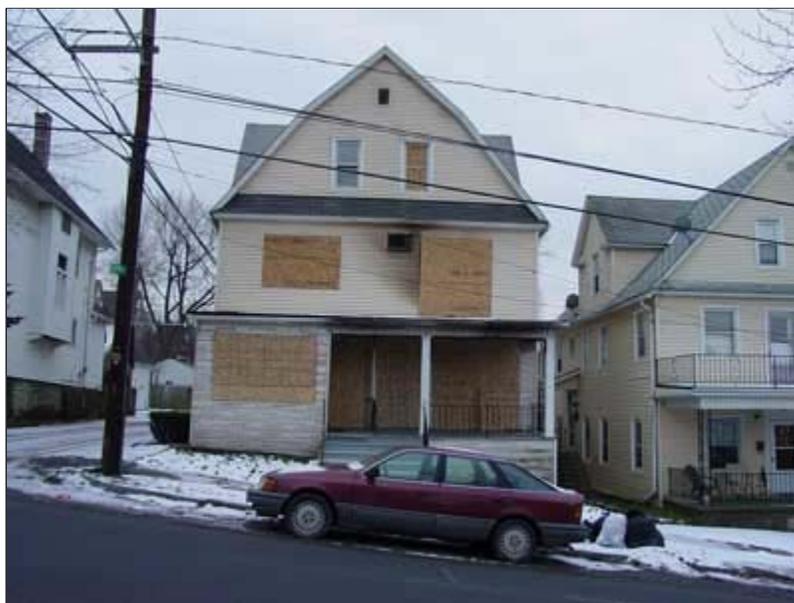
The fire building was a three-story residential house of wood frame construction that had been converted into three individual dwelling units, and was built sometime in the 1940's. The exterior consisted of aluminum siding, and asphalt shingles covered the roof. A three-phase 12,400-volt overhead powerline was located about 35-feet from the A-side of the structure and approximately 25-feet above ground level ([see Photos 1 and 2](#)).

R1's crew, being one of the first units to arrive on scene at about 0714 hours, gave a size-up of a three-story apartment building with heavy smoke showing ([see Photo 1](#)). Incident Command was established at the A-B corner of the fire structure, 1 ¾-inch attack hoselines were laid to the A-side of the structure, supply lines were stretched to the engines, and a water supply established. Forcible entry was made into the structure, and fire fighting and primary search activities commenced. Soon thereafter, fire fighters located an unconscious occupant inside the building on the second floor. The occupant was removed to the outside after the incident, and later pronounced dead at the scene by the local coroner. *Note: Sometime later in the incident, another occupant of the building was found on the second floor and also pronounced dead at the scene by the local coroner.*

**Photo 1. Side-A of three story apartment building (incident scene).
(NIOSH photograph.)**

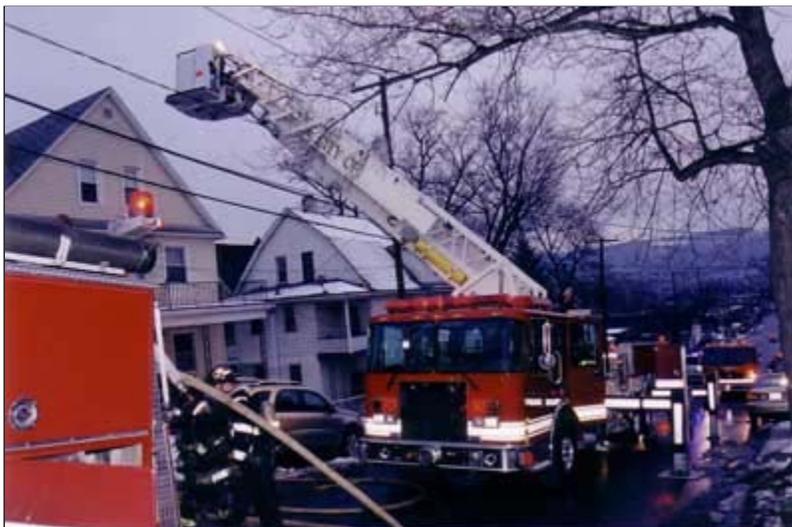
The apparatus involved in the incident (Truck 2) was a 2002 model, 85-foot mid-mount, elevating platform. Four warning signs were present on Truck 2. A sign was located on the turntable operator's controls cover and a similar sign was located on the back side of the platform. The signs stated – *Danger -Electrocution Hazard - This machine is not insulated against electrical shock! Keep this apparatus a safe distance from power lines. Allowances must be made for sway, rock or sag of power lines and this machine. Contact with or inadequate clearance from power lines can result in serious injury or death. Also, a sign was located on the pump panel on both sides of the apparatus. The sign stated – Danger - Electrocution Hazard - Keep Clear – Death or serious injury can result from contact with this equipment or vehicle if it should be electrically charged.* ([See Photos 3 and 4](#)).

In this incident, a decision was made to ventilate the apartment building by using the elevating platform on T2 to gain access to the roof. T2 had been spotted in a position that required the aerial device to be maneuvered around a 12,400 volt powerline. Believing the powerlines had been de-energized the victim raised the elevating platform and extended it between the powerlines and communication lines. During this process, his neck and back came into contact with the energized powerline.

Photo 2. Truck 02 - 2002 model, 85-foot mid-mount, elevating platform.
*(Photograph taken shortly after the incident occurred
by off duty fire fighter Bill Boock.)*

Discussion: Aerial device drivers/operators must continually be aware of overhead powerlines. When parking the aerial apparatus, it is just as important to look up as it is to look at the ground. If possible, the driver/operator should spot the apparatus in a position that will require minimum or no maneuvering of the aerial apparatus around obstructions. The goal is always to maintain a distance of at least 10 feet (3 m) between the aerial device and overhead electric lines.³ Additionally, aerial device drivers/operators should be, at a minimum, trained to maintain a 10 foot distance from overhead powerlines; verify that powerlines have been de-energized; recognize hazards associated with operating an aerial device in proximity to overhead powerlines; and understand procedures for emergency situations (e.g. in the event an aerial device contacts an electrical powerline, fire fighters on the ground should never make contact with the aerial device or allow anyone else to contact it).

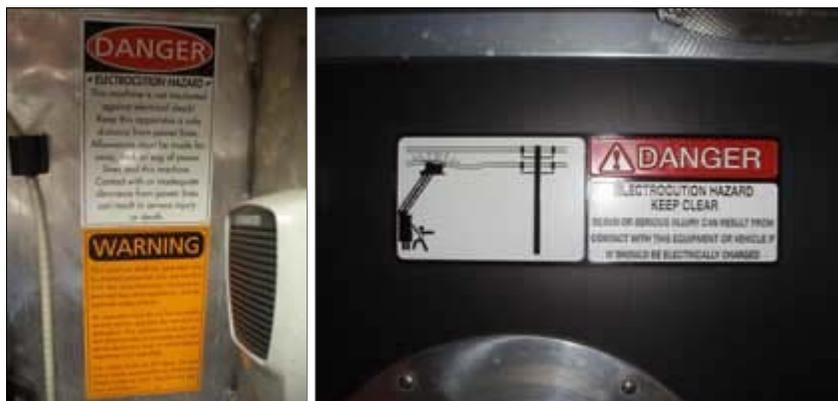
**Photos 3 and 4. Shown here are two of the four
warning signs affixed to Truck 2.**

Discussion: The following safety warning was printed in the manufacturer's "Trained Engineer's Manual" for operation of the elevating platform apparatus used at this incident: "Safety Warning! Avoid overhead electrical power lines! The aerial ladder is not insulated. If the ladder comes into close proximity/and or contacts any electrical power source, severe injury or death may occur to the Ladder Engineer, Ladder occupants, and possibly persons in close proximity to any part of the apparatus. Remember, the only safe power line is NO power line."¹⁰ In this incident, the fire department did not verify the utility company's report that the powerlines had been de-energized. Manufacturers' warnings for safe operation of equipment should always be followed.

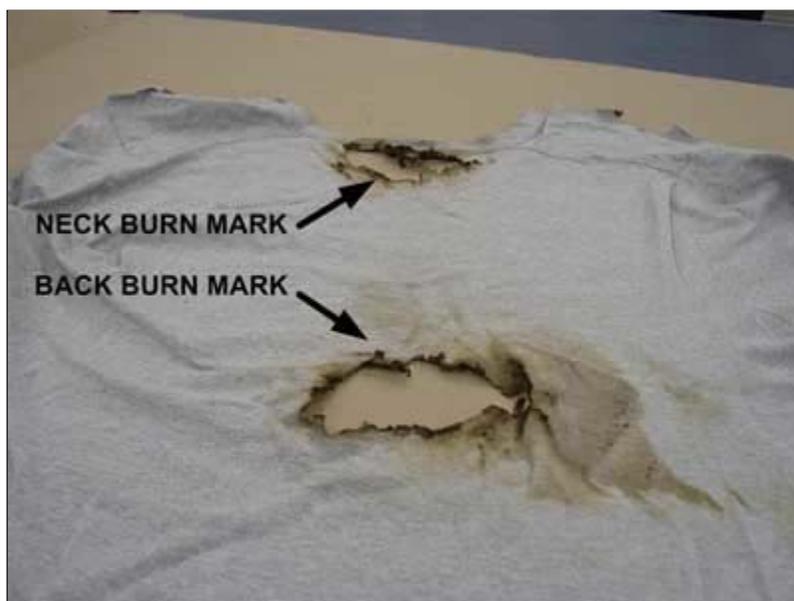
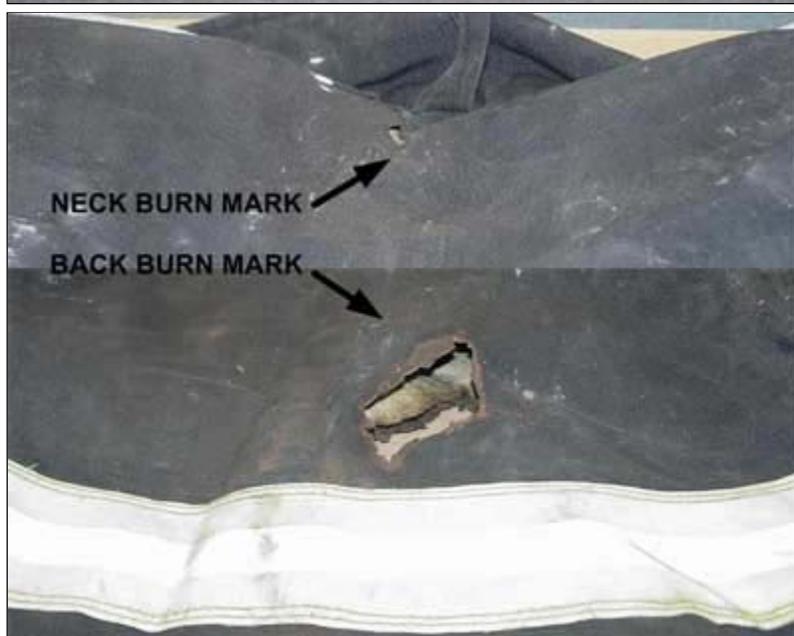
The victim instructed the fire fighter that they were going up in the platform. The victim retrieved a chain saw and he and the fire fighter climbed onto the platform of the elevating platform. Using the controls in the platform, the victim swung the platform out of its bed and toward the fire structure, and started extending the boom ([see Photo 2](#)). As the platform approached the overhead electrical wires, the fire fighter crouched down onto the platform and then heard an electrical arching (crackling) noise. The fire fighter looked up and saw a wire on the victim's back ([see Photos 5 and 6](#)). The arching stopped as the victim slumped down over the controls and fell back onto the platform.

Photos 5 and 6. Victim's T-shirt and bunker jacket with burn marks on the neck and back area from contact with the energized electrical powerline.
(NIOSH photographs.)

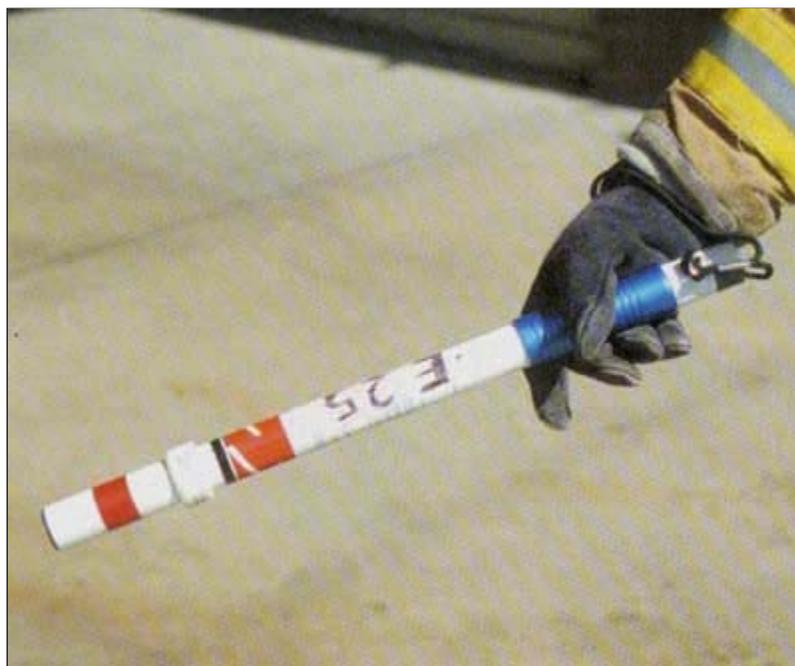
Discussion: Written standard operating guidelines (SOGs) or standard operating procedures (SOPs) enable individual fire department members an opportunity to read and maintain a level of assumed understanding of operational procedures. Fire departments can suffer when there is an absence of well developed SOGs or SOPs. The NIOSH Alert: “Preventing Injuries and Deaths of Fire Fighters” identifies the need to establish and follow fire fighting policies and procedures.¹ Guidelines and procedures should be developed, fully implemented, and enforced to be effective. Periodic refresher training should be provided to assist fire fighters in remembering and understanding departmental guidelines and procedures. These SOGs or SOPs should include hazardous energy control procedures. The use of alternating current detectors to verify that powerlines are de-energized should be included in any hazardous energy control procedures developed by fire departments. *Note: Alternating current (AC) detectors can detect unshielded AC through snow, ice, and many solid objects. These battery-operated devices are handheld wands similar in size and shape to a police officer’s baton. In the presence of an AC, they emit an intermittent beep. The more rapid the beep, the closer the source is. The detection range (distance from the source at which the wand detects the current) varies with the situation. In general, the higher the voltage, the greater the ranges will be² (see Photo 7).*

Photo 7. Alternating current detector.
(Photograph courtesy of the International Fire Service Training Association.)

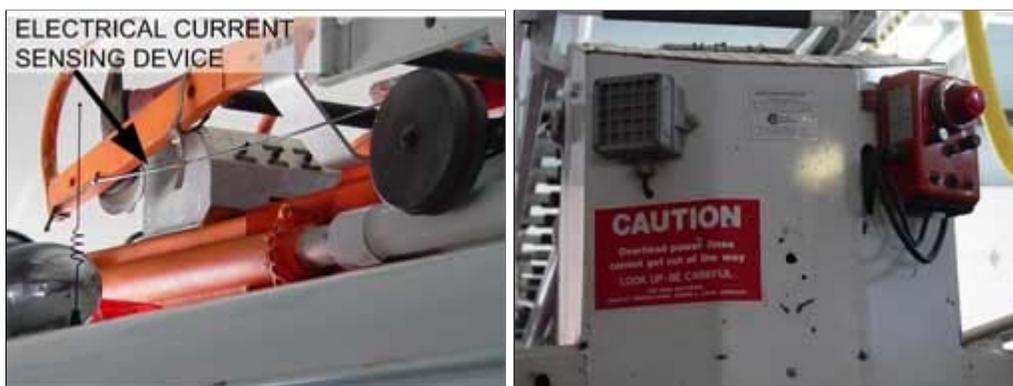
Photos 8 and 9. Example of proximity warning device used on aerial ladder truck at neighboring fire department. Photos left to right – electrical current sensing device, and alarm and control box.
(Photographs courtesy of neighboring fire department.)

Recommendation #5: Fire departments should use proximity warning devices to detect electrical current when working near exposed potentially energized parts (e.g. overhead powerlines) as a secondary/redundant means of protection.

Discussion: Proximity warning devices are used to detect the electrostatic field of any alternating current (AC) power line. They provide both audible and visual warning signals to alert the operator and attendant or ground personnel when the boom comes within the proximity of an energized high-voltage power line.⁹ These devices can help verify that lines are de-energized ([see Photos 8, and 9](#)). However, they should not be relied upon as the sole or primary means of verifying whether powerlines are de-energized.
